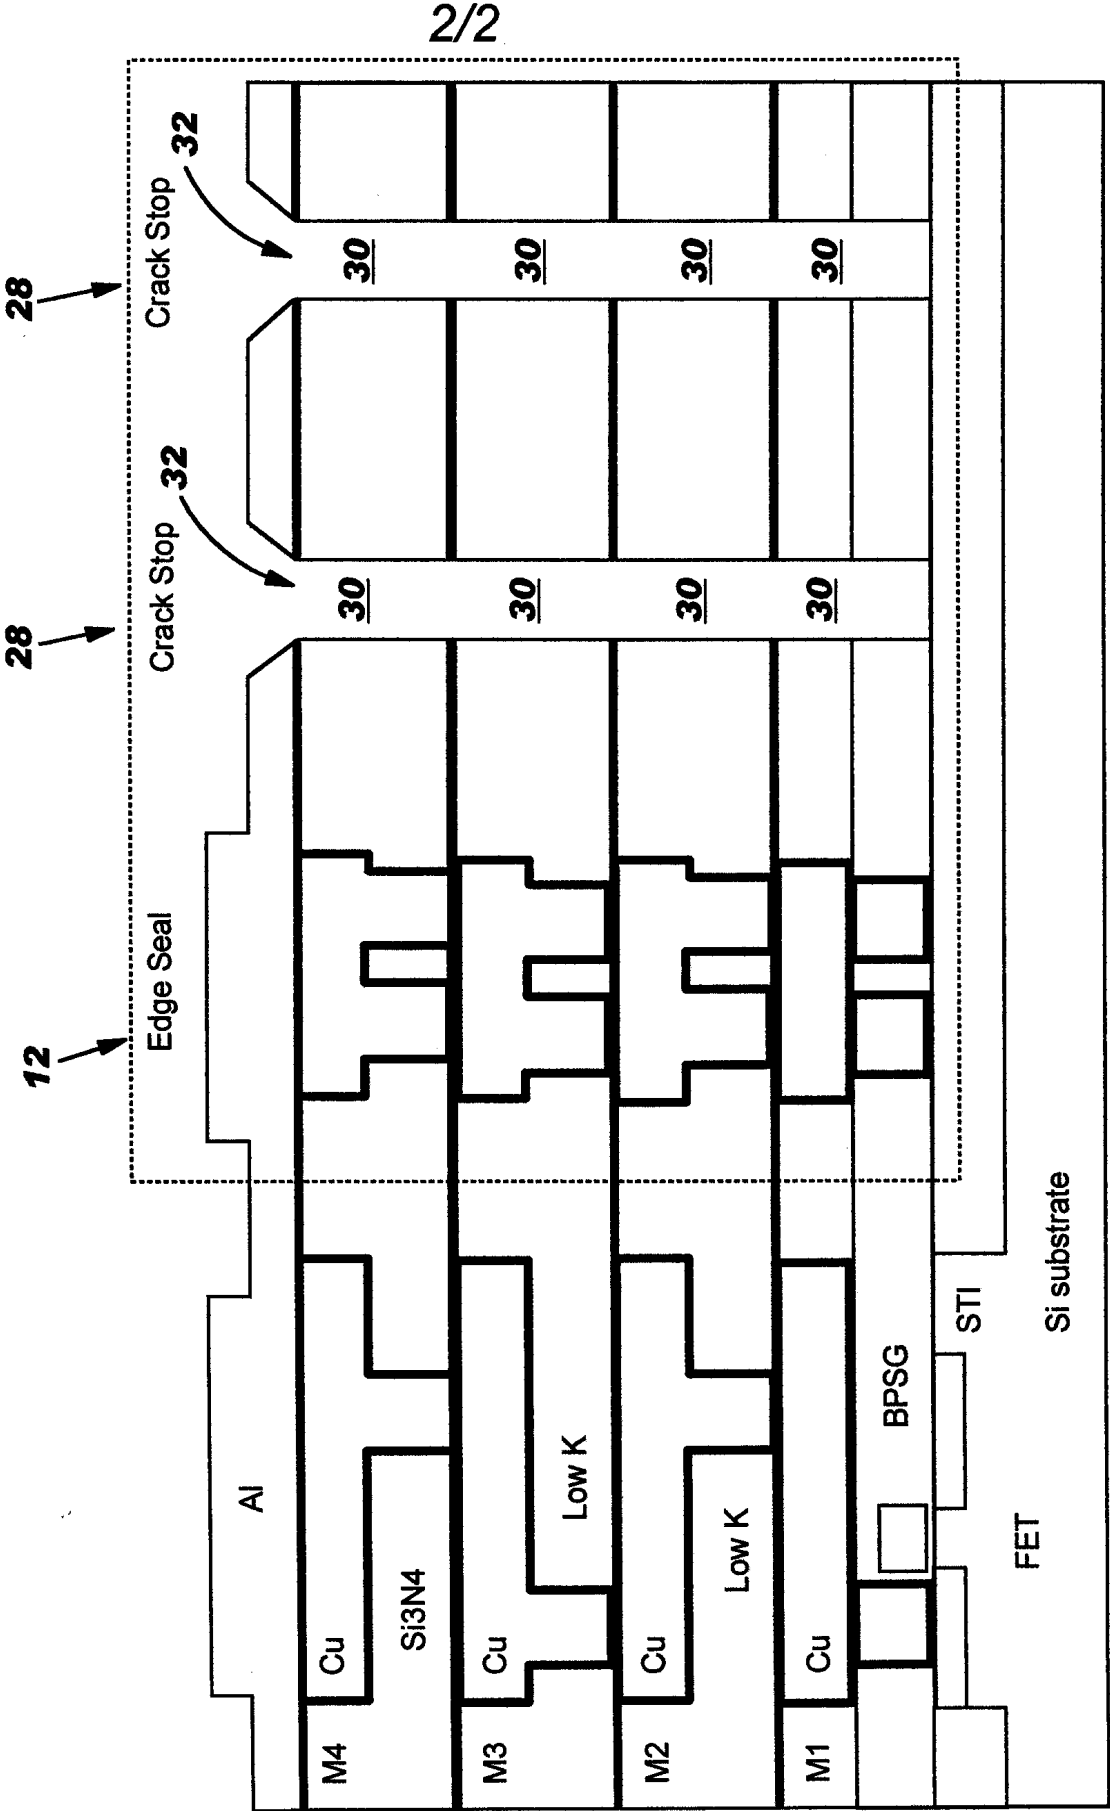
FIG. 2

Crack stop with metal removed
